# SUBARU Telescope Damages and Recovery from the Earthquake

**Tomonori USUDA**  
(SUBARU Telescope)

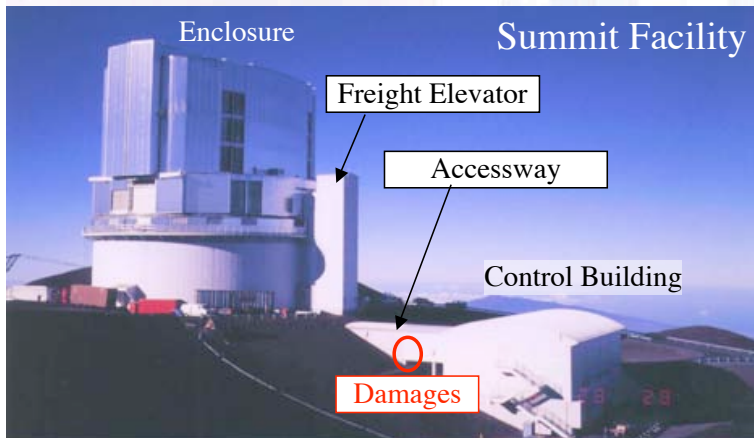
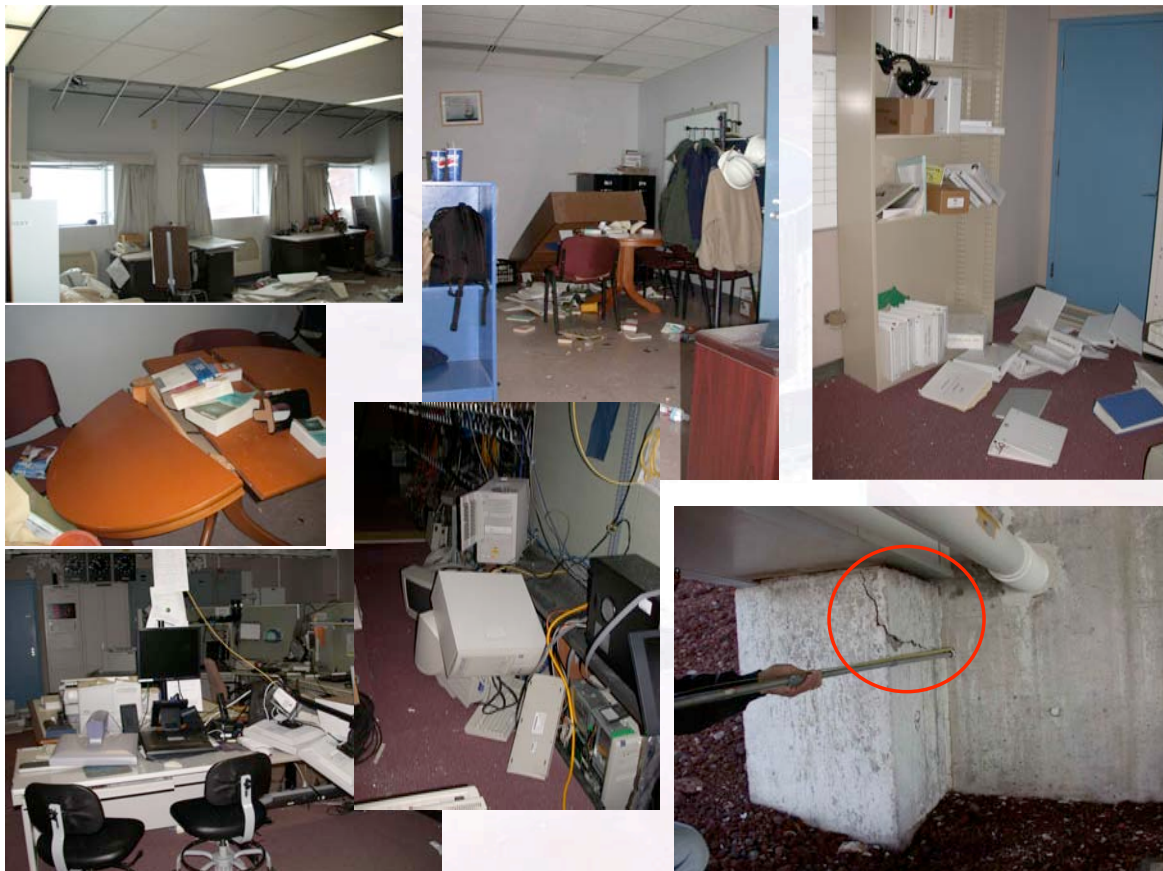
## 2. Damages at the summit facility

- One of the four slide guide was broken on the freight elevator.  
→ 10/17 (temporally repair), 11/6 (Repair done)
- Ceiling boards, computers, displays, etc. were fallen at the 3rd floor of the control building.
- Several cracks on the walls of the control building.
- Some cracks in the foundation of the access way between the enclosure and the control building.

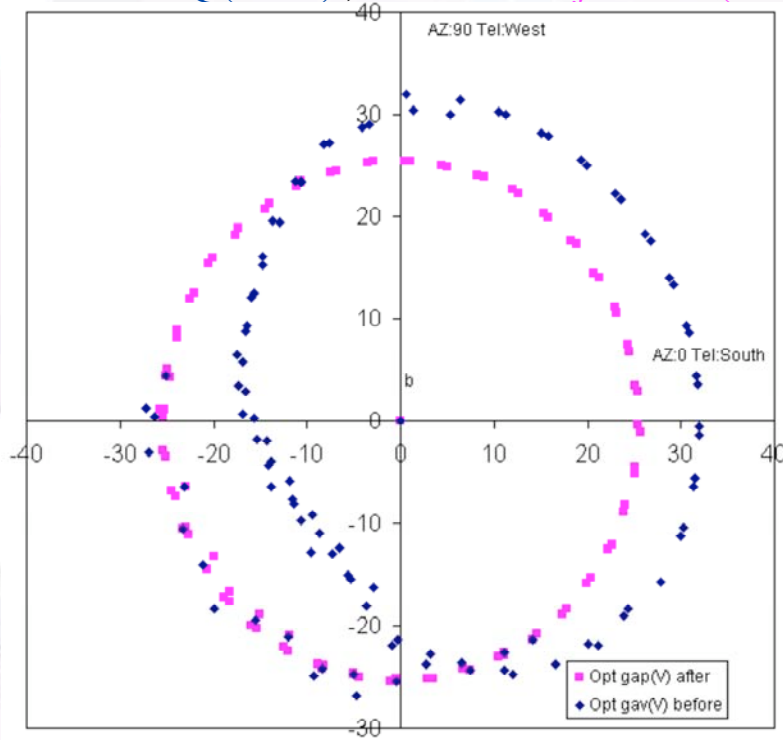
Comparison between before/after adjustment  
 Blue: After EQ (10/19), Red: After adjustment (10/24)

separation between encoder tape and detector (10 μm)

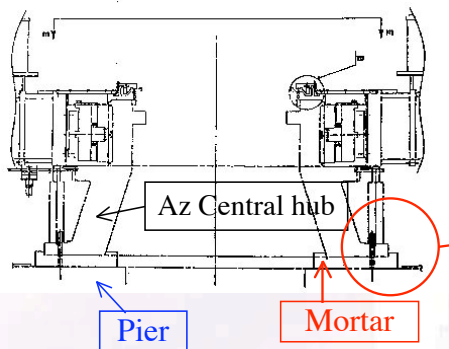
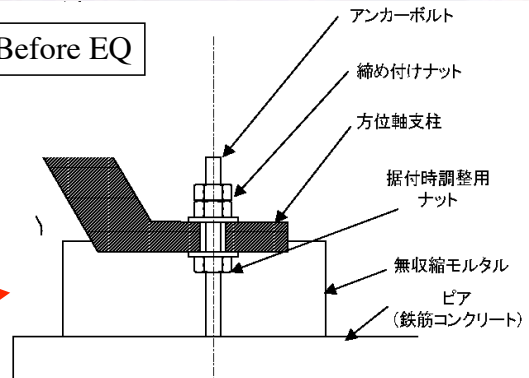
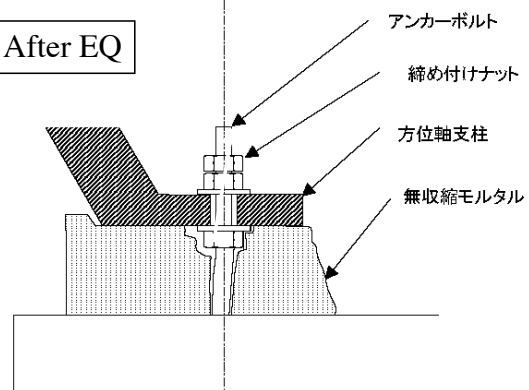
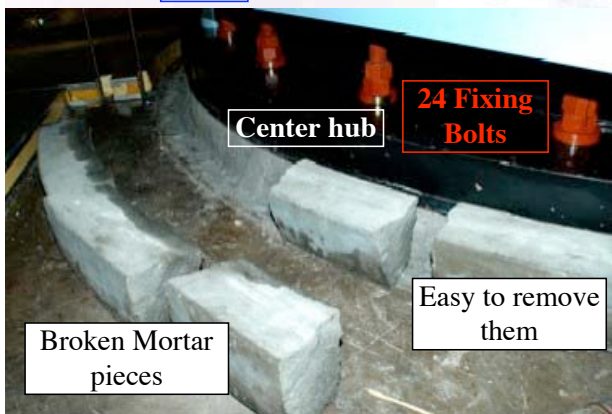
**Center hub shifted**

- **About 1.2mm shifted toward South-West direction**  
→ The tracking accuracy was worse, since the separation between Az incremental encoder tape and its detector was changed (**normally 0.25mm**).
- Shift the hub back to the original position → Difficult & Give up
- **Shift the position of the Az encoder tape**
- **Non-shrink mortar around the hub was broken.**  
→ Difficult to refill and spread mortar between the center hub and the pier, thus the **mechanical steel ring structure** is designed and will be installed around the hub in order to support it in May.

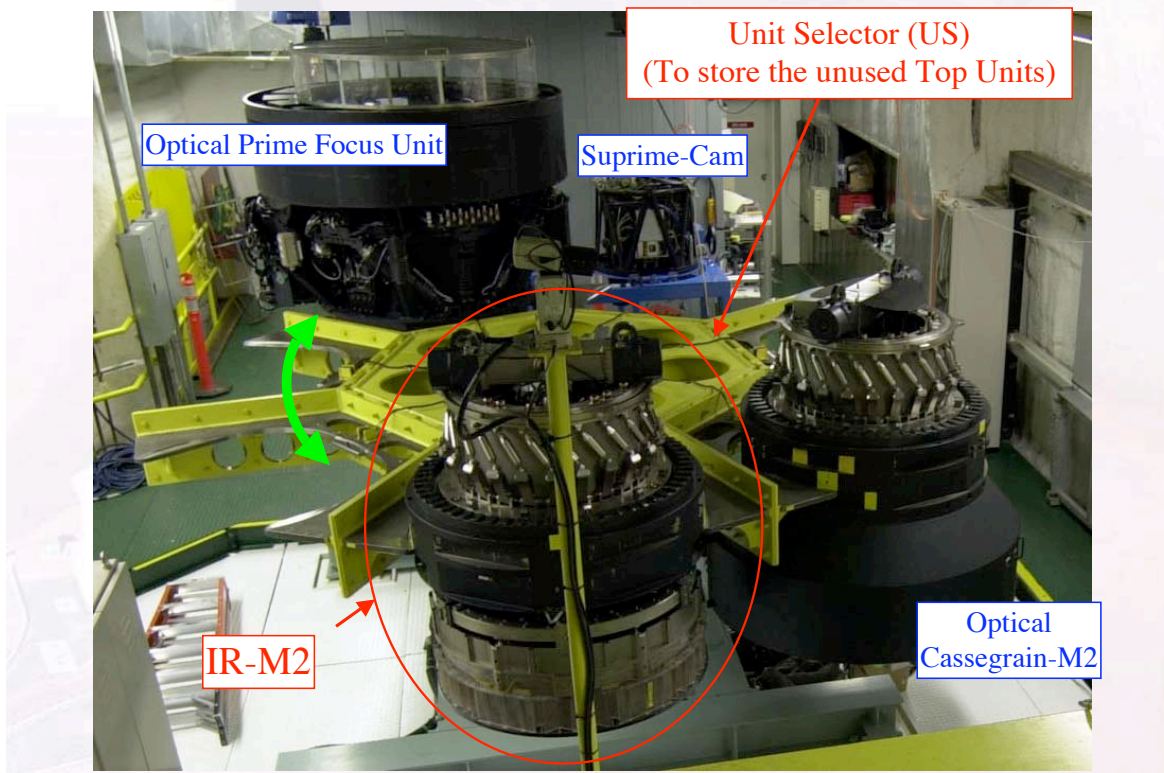
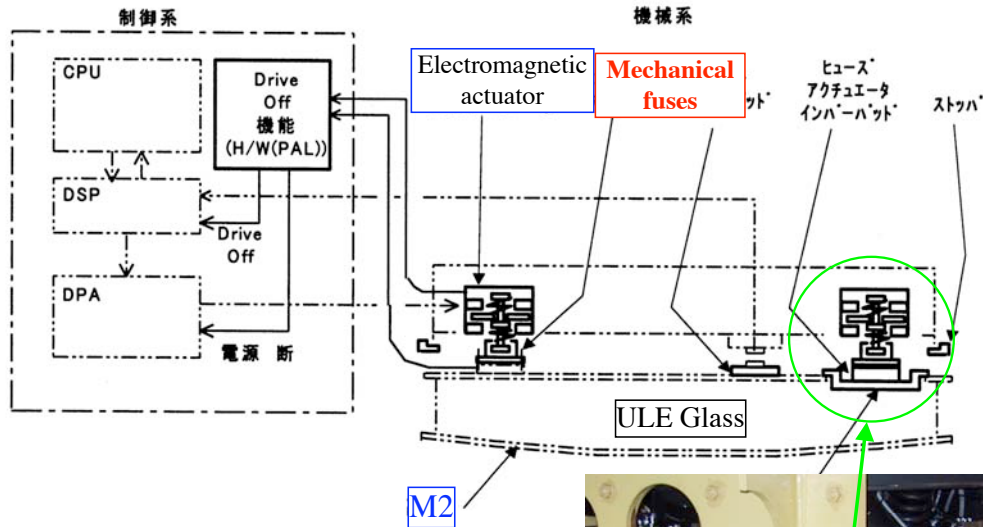
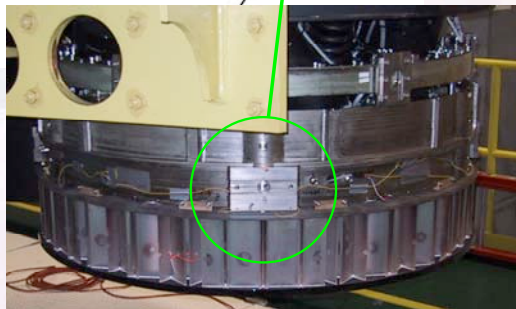
# IR-M2 Unit: Mechanical Fuse

- The **mechanical fuses were broken** which have been installed between the M2 glass and the electromagnetic actuator to protect glass.  
→ Disassemble the M2 unit to replace fuses.

The **mechanical fuses** are working, in order to protect glass due to impacts, over-loads, etc.

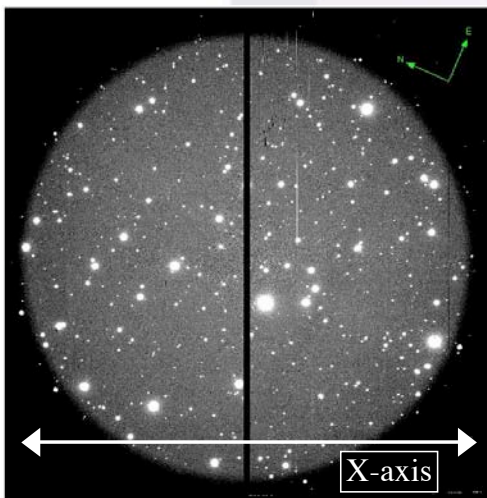
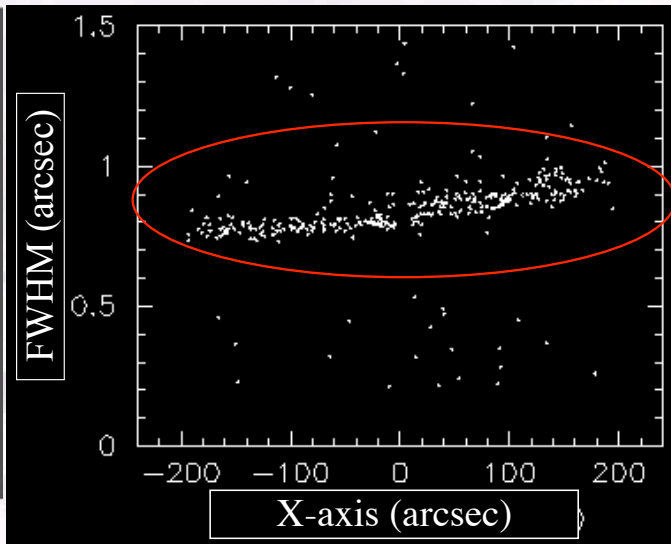
# Tilted Focal plane: Results from FOCAS @Cs focus

- Images taken by FOCAS
    - ◇ Astigmatism (aberration) was seen.
    - ◇ Focal plane was tilted → Best focus position was different in the FOV.
- Primary mirror was shifted. Mirror analysis works for all foci are on going.

→ **Adjust M2 positions**

1. Instruments (e.g., MOIRCS, IRCS, S-Cam) were used to check image quality.
2. Cs-IR (Dec.26) / Cs-Opt focus (Dec.22) / PF-Opt (Nov.16) / NsIR (Nov.06) / NsOpt (Dec.07 & Jan.24)
3. There are **29 modes!** Moreover, some software bugs are found.

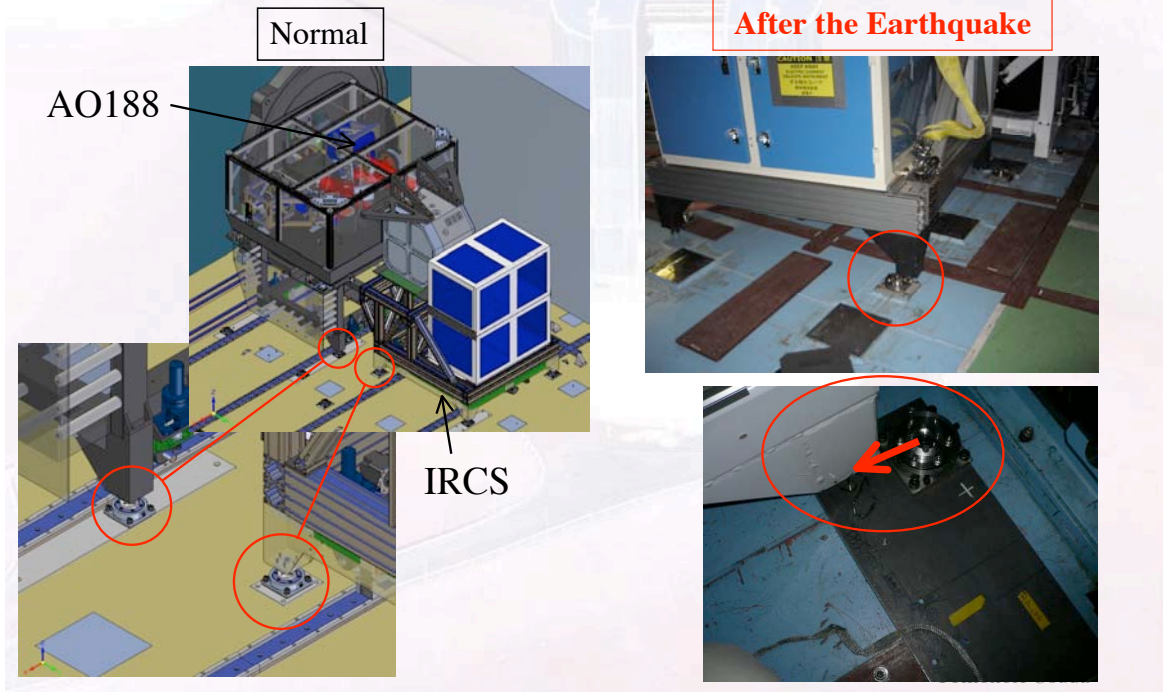
## 4. Damages on the instruments: IRCS & AO188

Both AO188 and IRCS were fallen off from the fixed bases.

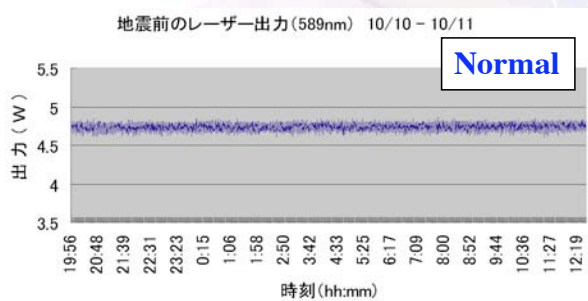
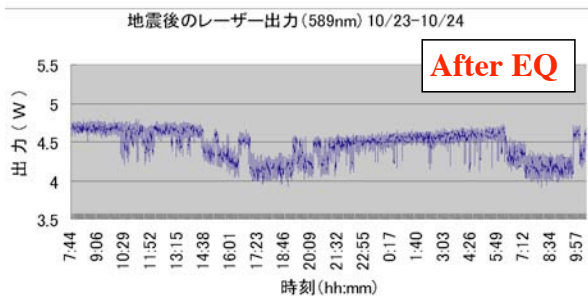
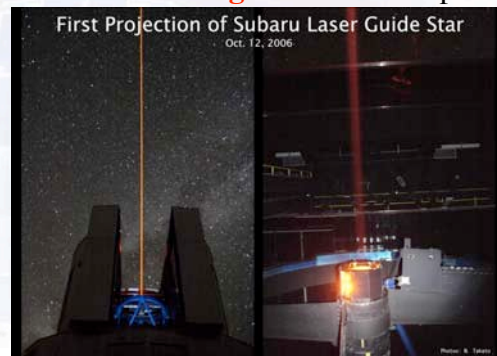
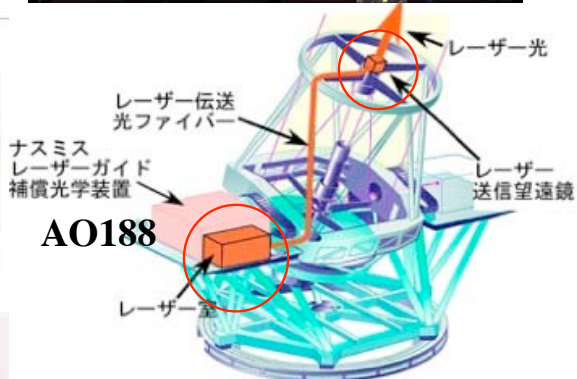
## 4. Damages on the instruments: LGS

The output is **unstable** after the earthquake due to the **misalignment** of the optical and laser parts (~0.01 mm).

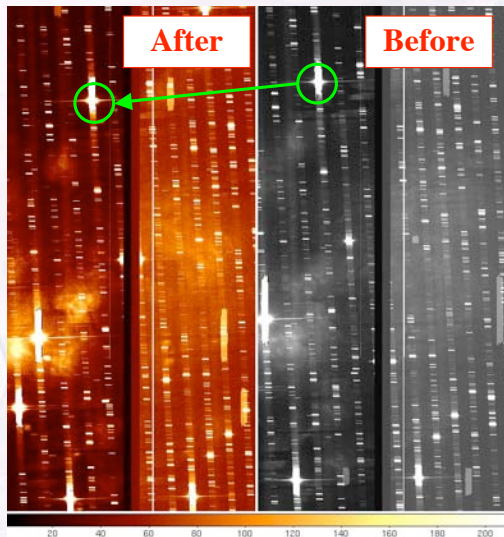
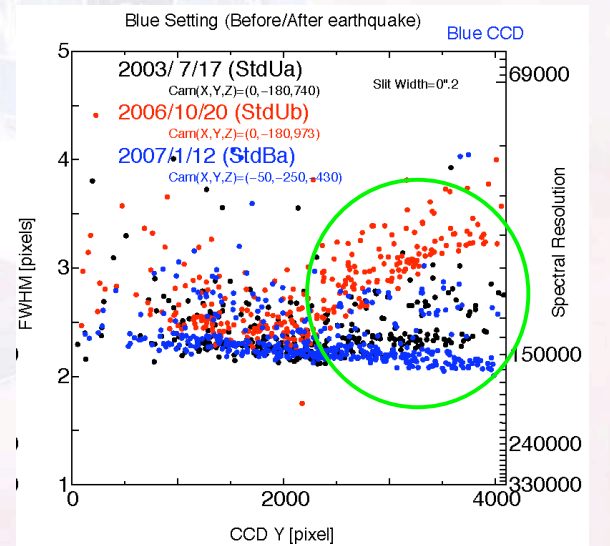
## 4. Damages on the instruments: HDS

Misalignment of the optics and CCD camera unit.

→ **Worse spectral resolution and tilted focal plane**

- Installation accuracy was  $\sim 0.1$ mm.
- Non-uniform spectral resolution on the CCD with  $0.2''$

→ **Re-adjustment works had been successfully done on Jan.17.**
