# SUBARU Telescope Damages and Recovery from the Earthquake

**Tomonori USUDA**  
(SUBARU Telescope)

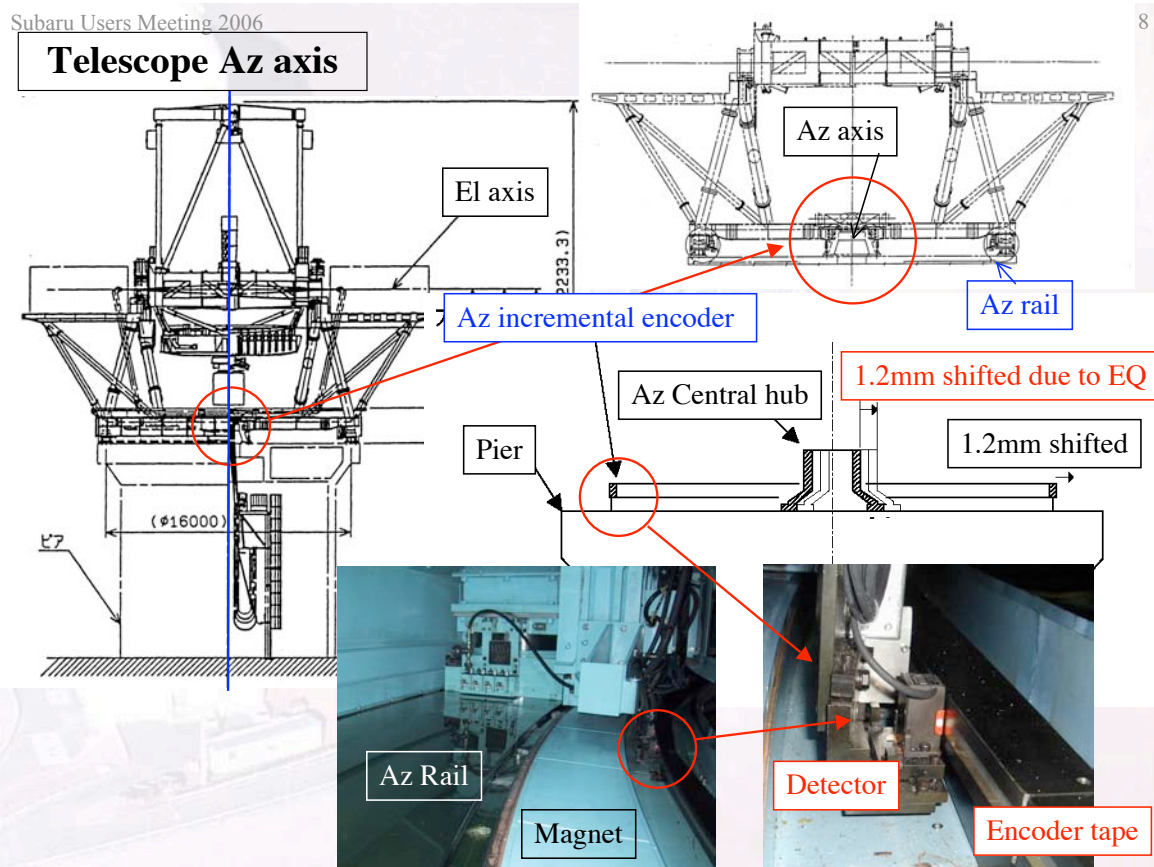
#### ∞ Center hub of the Az axis was moved.

- **About 1.2mm shifted toward South-West direction**  
→ The tracking accuracy was worse, since the separation between Az incremental encoder tape and its detector was changed (**normally 0.25mm**).
- Shift the hub back to the original position → Difficult & Give up
- **Shift the position of the Az encoder tape**
- **Non-shrink mortar around the hub was broken.**  
→ Difficult to refill and spread mortar between the center hub and the pier, thus the **mechanical steel ring structure** is designed and will be installed around the hub in order to support it in May.

Comparison between before/after adjustment  
 Blue: After EQ (10/19), Red: After adjustment (10/24)

separation between encoder tape and detector (10 μm)
